# MALAD CITY AIRPORT

This report describes how your pavement maintenance management program was developed. This program was developed as part of the Network Pavement Management Program project sponsored by the Idaho Transportation Department, Division of Aeronautics. The information and data contained in this report ensures you are in compliance with the requirements of Federal Aviation Administration (FAA) Grant Assurance Number 11 which states that any airport requesting federal funds for pavement improvement projects must have implemented a pavement maintenance management program (PMMP).

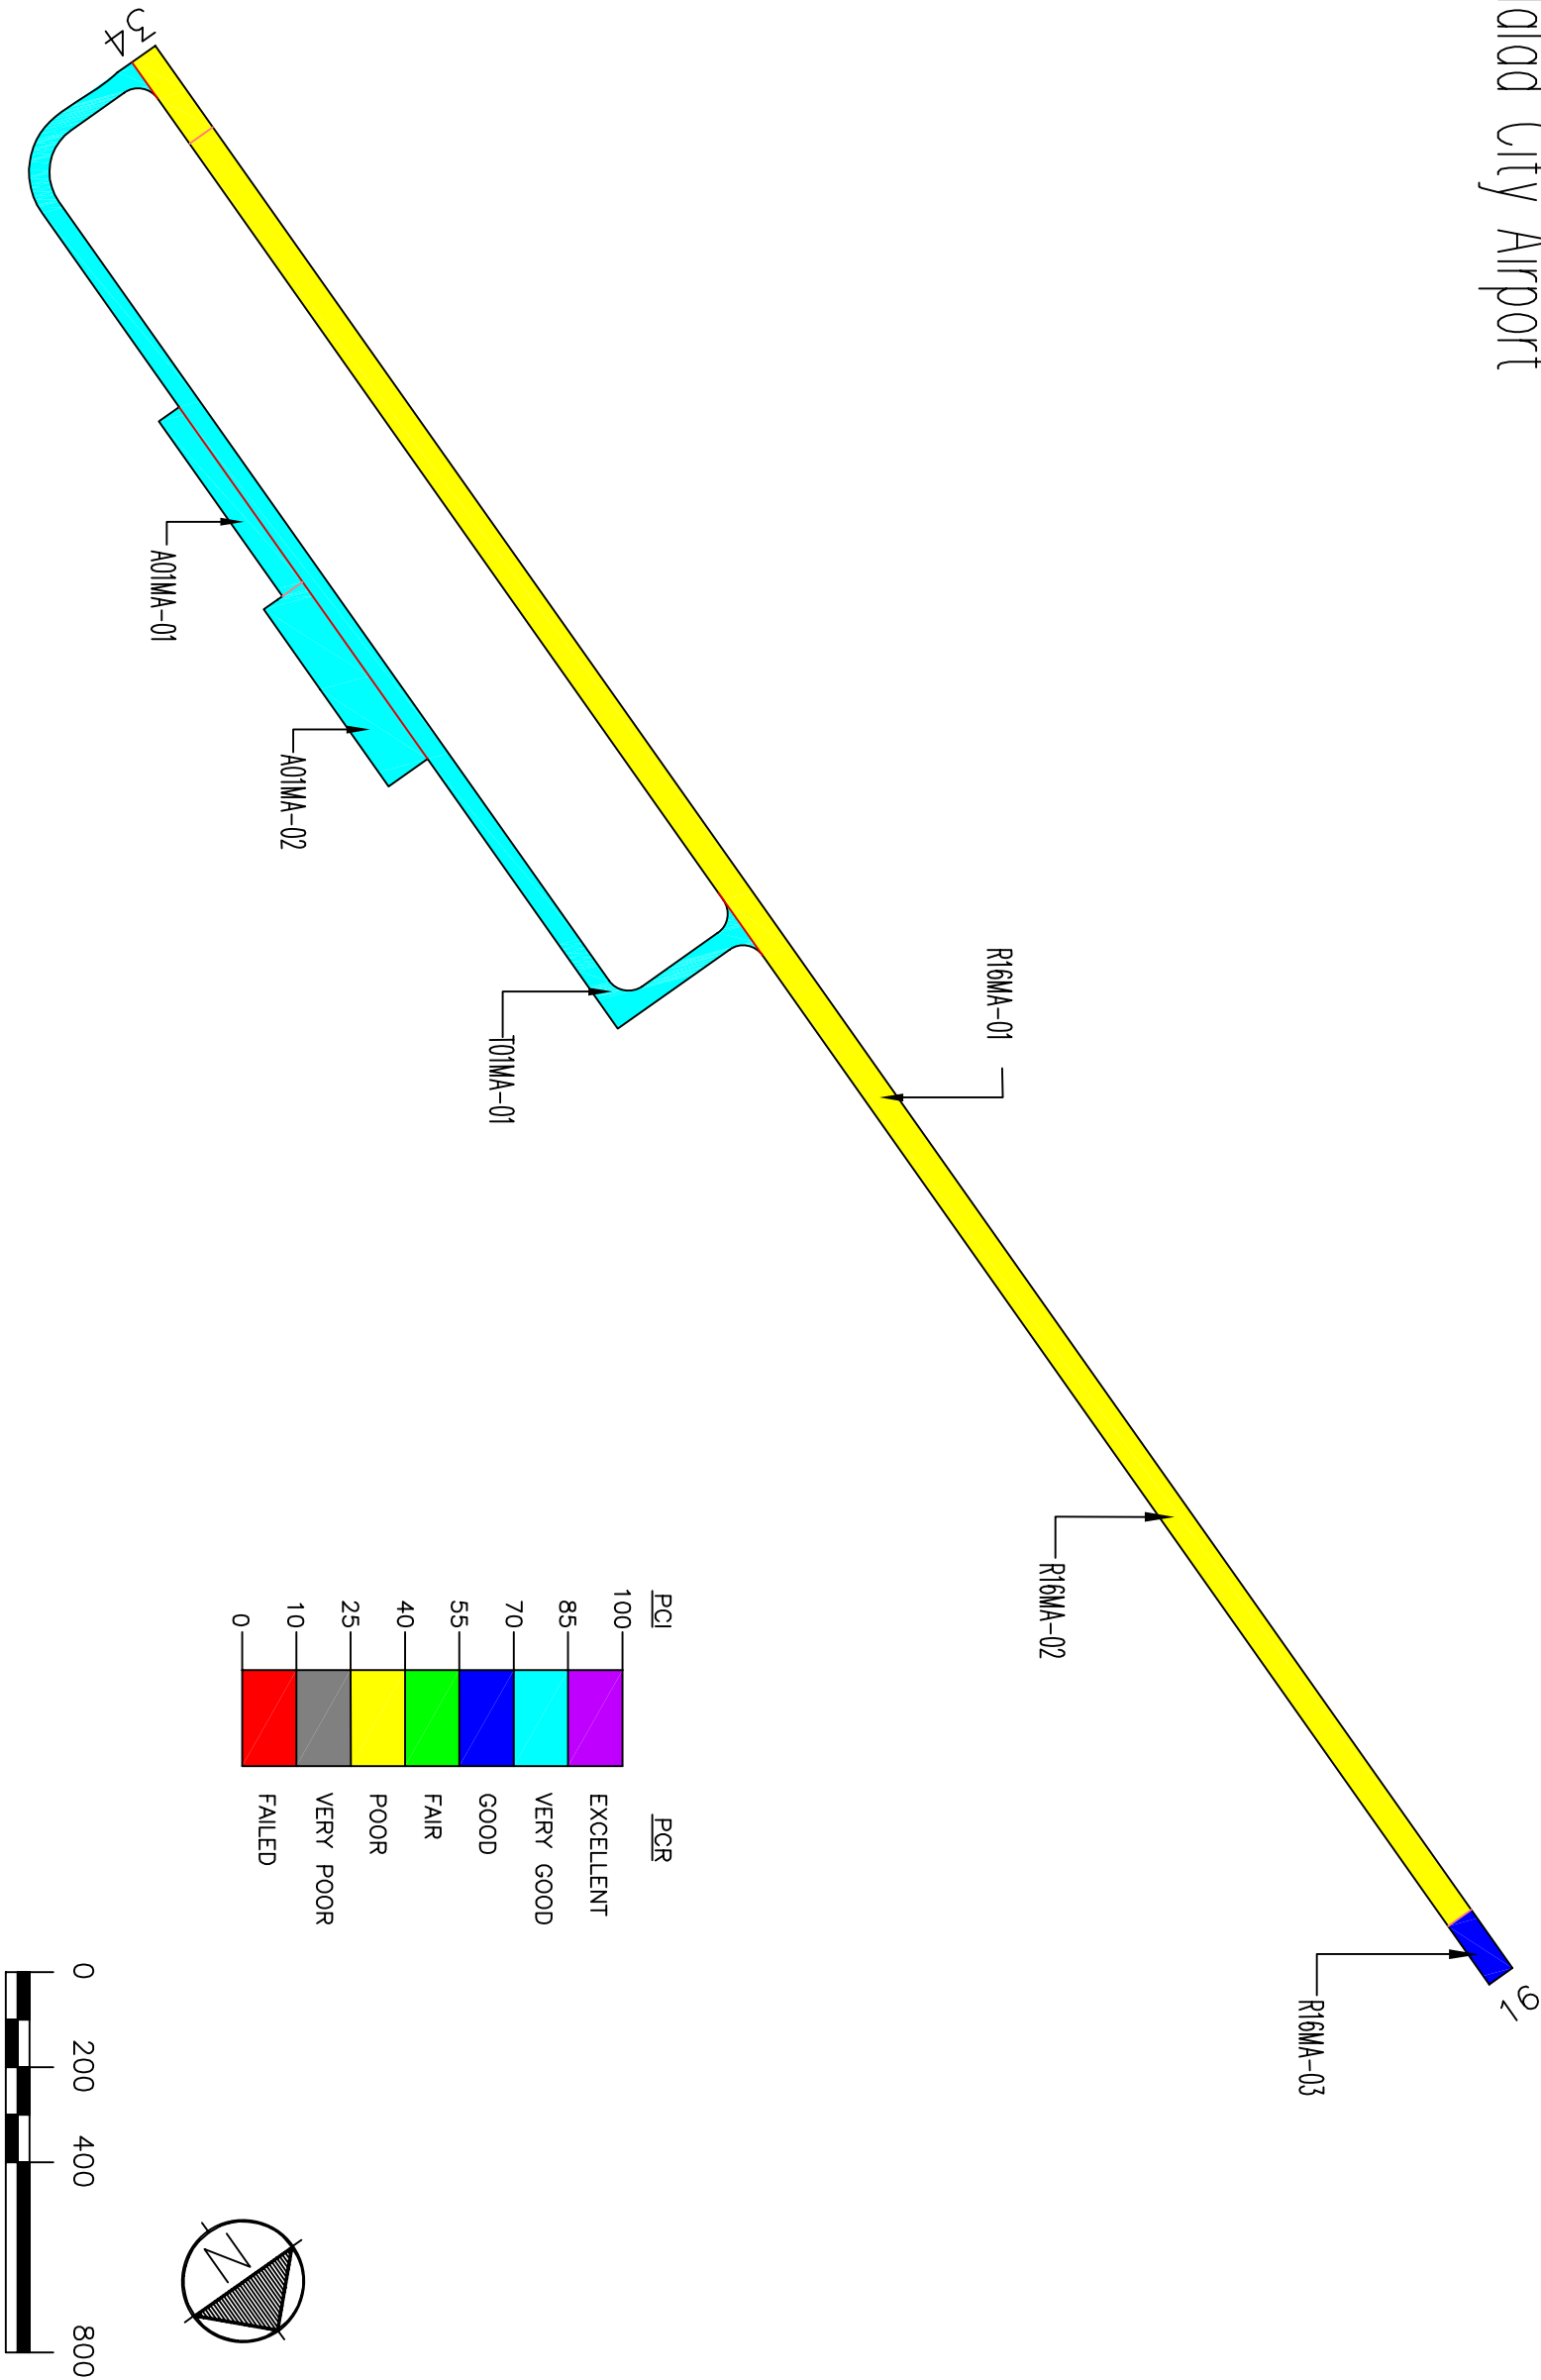
Figure MA-3. Pavement Condition in 2006.  
Malad City Airport

Using the data collected during the visual inspection, the Micro PAVER software calculated a Pavement Condition Index (PCI) for each pavement section inspected by averaging the PCIs for inspected sample units. Using each section’s PCI, a Pavement Condition Rating (PCR) was assigned. The PCIs and associated PCRs from this inspection are shown in Table MA-2. This table also contains projected PCIs for 2011 and 2016 based on pavement deterioration models developed by Micro PAVER using the inspection data from pavements in Idaho having the same surface types. The Branch Condition Report in Appendix 2 summarizes current pavement condition by branch while the Section Condition Report in Appendix 2 lists pavement condition by section. The current PCR is shown graphically in Figure MA-3.

Section PCIs at the airport range from a low of 28 (a PCR of “Poor”) to a high of 81 (a PCR of “Very Good”). The area-weighted average PCI for all airport pavements is 51, corresponding to an overall PCR of “Fair”. Figure MA-4 shows how much pavement area is associated with each Pavement Condition Rating category and also shows pavement condition distribution from the inspections conducted in 1996 and 1999. A graphical representation of the projected PCRs presented in Table MA-2 is shown in Figure MA-5.

The primary distresses observed during the inspection were alligator cracking, longitudinal and transverse cracking, weathering/raveling, patching, and slippage cracking with isolated distresses of depressions.

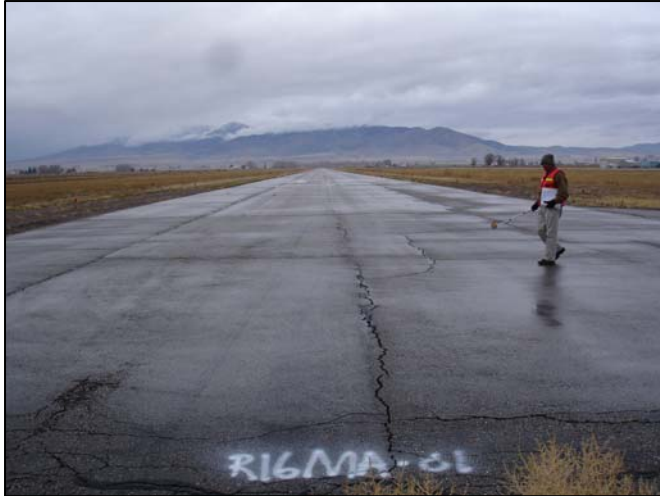
Sample Number: 01	Type: R	Area: 6,000.00SqFt	PCI = 24
41 ALLIGATOR CRACKING	M	574.00 SqFt	
45 DEPRESSION	L	16.00 SqFt	
48 LONGITUDINAL/TRANSVERSE CRACKING	M	349.09 Ft	
55 SLIPPAGE CRACKING	N	357.00 SqFt

Sample Number: 02	Type: R	Area: 6,600.00SqFt	PCI = 31
41 ALLIGATOR CRACKING	M	560.00 SqFt	
48 LONGITUDINAL/TRANSVERSE CRACKING	L	70.02 Ft	
48 LONGITUDINAL/TRANSVERSE CRACKING	M	360.09 Ft	
55 SLIPPAGE CRACKING	N	63.00 SqFt

Section: R16MA-01  
 Alligator Cracking  
 Longitudinal/ Transverse Cracking  
 Slippage Cracking

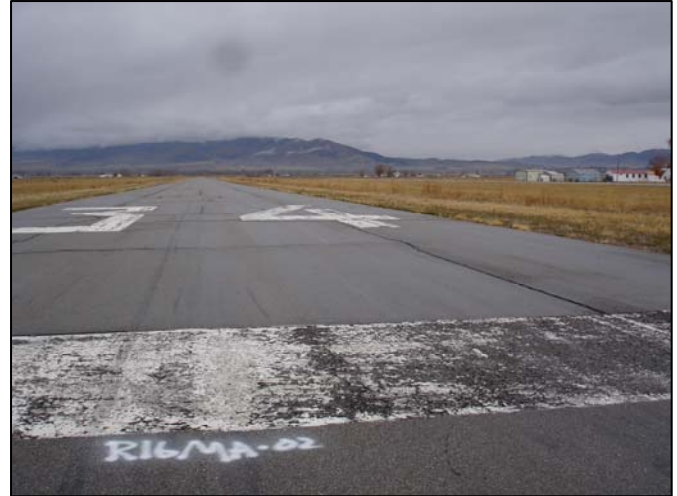
Sample Number: 01 Type: R Area: 6,000.00SqFt PCI = 21  
41 ALLIGATOR CRACKING L 60.00 SqFt  
45 DEPRESSION L 25.00 SqFt  
48 LONGITUDINAL/TRANSVERSE CRACKING L 20.01 Ft  
48 LONGITUDINAL/TRANSVERSE CRACKING M 370.09 Ft  
48 LONGITUDINAL/TRANSVERSE CRACKING H 30.01 Ft  
55 SLIPPAGE CRACKING N 1,165.99 SqFt

Sample Number: 09 Type: R Area: 6,000.00SqFt PCI = 49  
41 ALLIGATOR CRACKING M 180.00 SqFt  
48 LONGITUDINAL/TRANSVERSE CRACKING L 100.03 Ft  
48 LONGITUDINAL/TRANSVERSE CRACKING M 280.07 Ft

Sample Number: 17 Type: R Area: 6,000.00SqFt PCI = 31  
52 WEATHERING/RAVELING M 12.00 SqFt  
41 ALLIGATOR CRACKING M 298.00 SqFt  
48 LONGITUDINAL/TRANSVERSE CRACKING M 485.12 Ft  
48 LONGITUDINAL/TRANSVERSE CRACKING H 120.03 Ft

Sample Number: 25 Type: R Area: 6,000.00SqFt PCI = 33  
41 ALLIGATOR CRACKING M 296.00 SqFt  
48 LONGITUDINAL/TRANSVERSE CRACKING L 100.03 Ft  
48 LONGITUDINAL/TRANSVERSE CRACKING M 335.09 Ft  
50 PATCHING L 420.00 SqFt  
52 WEATHERING/RAVELING L 520.00 SqFt

Sample Number: 28 Type: R Area: 6,000.00SqFt PCI = 11  
41 ALLIGATOR CRACKING M 3,574.97 SqFt  
50 PATCHING L 1,103.99 SqFt  
52 WEATHERING/RAVELING M 2,799.98 SqFt

Sample Number: 45 Type: R Area: 6,000.00SqFt PCI = 64  
41 ALLIGATOR CRACKING H 12.00 SqFt  
48 LONGITUDINAL/TRANSVERSE CRACKING L 92.02 Ft  
48 LONGITUDINAL/TRANSVERSE CRACKING M 311.08 Ft

Section: R16MA-02  
 Alligator Cracking  
 Longitudinal/ Transverse Cracking  
 Slippage Cracking  
 Weathering/ Raveling

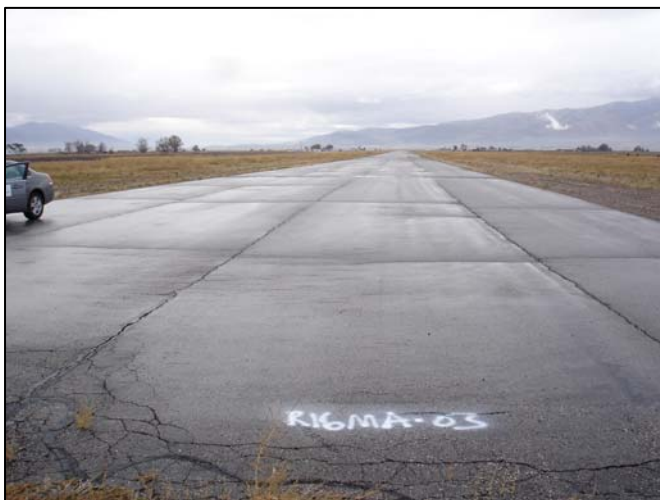
Sample Number:	01	Type:	R	Area:	4,980.00SqFt	PCI = 66
48	LONGITUDINAL/TRANSVERSE	CRACKING	L	50.01	Ft	
48	LONGITUDINAL/TRANSVERSE	CRACKING	M	310.08	Ft	
Sample Number:	02	Type:	R	Area:	4,020.00SqFt	PCI = 55
41	ALLIGATOR	CRACKING	M	17.00	SqFt	
48	LONGITUDINAL/TRANSVERSE	CRACKING	L	15.00	Ft	
48	LONGITUDINAL/TRANSVERSE	CRACKING	M	400.10	Ft

Section: R16MA-03  
 Longitudinal/ Transverse Cracking

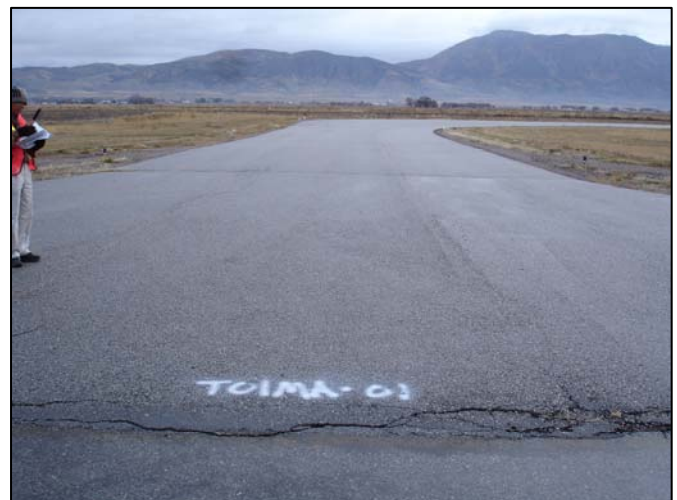
Sample Number: 01 Type: R Area: 4,450.00SqFt PCI = 73  
48 LONGITUDINAL/TRANSVERSE CRACKING L 147.04 Ft  
48 LONGITUDINAL/TRANSVERSE CRACKING M 103.03 Ft  
52 WEATHERING/RAVELING H 10.00 SqFt

Sample Number: 07 Type: R Area: 4,300.00SqFt PCI = 55  
41 ALLIGATOR CRACKING L 200.00 SqFt  
48 LONGITUDINAL/TRANSVERSE CRACKING L 150.04 Ft  
48 LONGITUDINAL/TRANSVERSE CRACKING M 50.01 Ft

Sample Number: 13 Type: R Area: 4,300.00SqFt PCI = 93  
48 LONGITUDINAL/TRANSVERSE CRACKING L 86.02 Ft

Sample Number: 19 Type: R Area: 4,300.00SqFt PCI = 93  
48 LONGITUDINAL/TRANSVERSE CRACKING L 77.02 Ft

Sample Number: 24 Type: R Area: 4,300.00SqFt PCI = 68  
48 LONGITUDINAL/TRANSVERSE CRACKING L 58.01 Ft  
48 LONGITUDINAL/TRANSVERSE CRACKING M 232.06 Ft

Sample Number: 28 Type: R Area: 5,136.00SqFt PCI = 80  
48 LONGITUDINAL/TRANSVERSE CRACKING M 122.03 Ft  
52 WEATHERING/RAVELING L 52.00 SqFt

Section: T01MA-01  
 Longitudinal/ Transverse Cracking

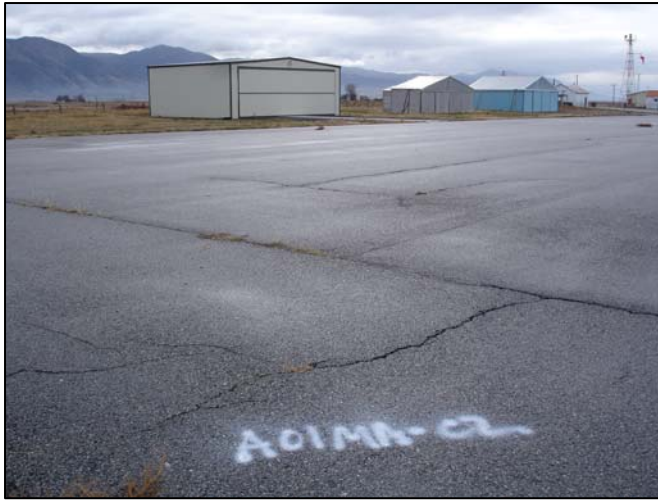
Sample Number: 02 Type: R Area: 5,000.00SqFt PCI = 79  
48 LONGITUDINAL/TRANSVERSE CRACKING L 272.07 Ft  
48 LONGITUDINAL/TRANSVERSE CRACKING M 30.01 Ft

Sample Number: 04 Type: R Area: 5,000.00SqFt PCI = 86  
48 LONGITUDINAL/TRANSVERSE CRACKING L 50.01 Ft  
48 LONGITUDINAL/TRANSVERSE CRACKING M 29.01 Ft

Sample Number: 06 Type: R Area: 5,000.00SqFt PCI = 82  
48 LONGITUDINAL/TRANSVERSE CRACKING L 203.05 Ft  
48 LONGITUDINAL/TRANSVERSE CRACKING M 23.01 Ft

Sample Number: 08 Type: R Area: 5,000.00SqFt PCI = 76  
48 LONGITUDINAL/TRANSVERSE CRACKING L 17.00 Ft  
48 LONGITUDINAL/TRANSVERSE CRACKING M 160.04 Ft

Sample Number: 09 Type: R Area: 5,000.00SqFt PCI = 81  
48 LONGITUDINAL/TRANSVERSE CRACKING L 186.05 Ft  
48 LONGITUDINAL/TRANSVERSE CRACKING M 80.02 Ft

Section: A01MA-02  
Longitudinal/ Transverse Cracking

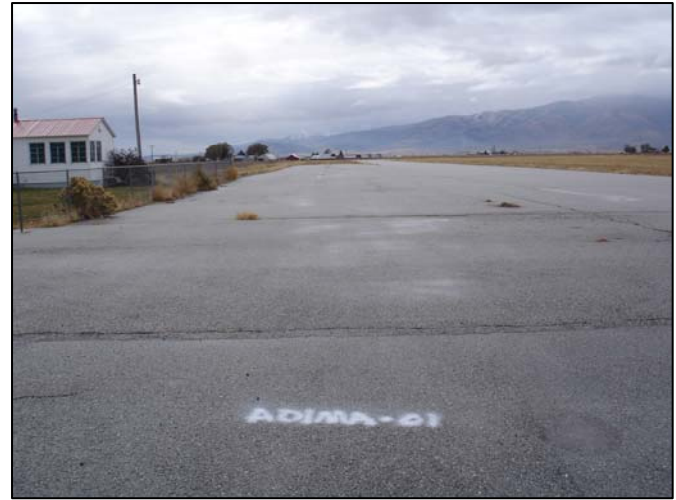
Sample Number: 03 Type: R Area: 5,200.00SqFt PCI = 77  
48 LONGITUDINAL/TRANSVERSE CRACKING L 133.03 Ft  
48 LONGITUDINAL/TRANSVERSE CRACKING M 132.03 Ft

Sample Number: 04 Type: R Area: 5,200.00SqFt PCI = 64  
41 ALLIGATOR CRACKING L 20.00 SqFt  
45 DEPRESSION L 40.00 SqFt  
48 LONGITUDINAL/TRANSVERSE CRACKING L 187.05 Ft  
48 LONGITUDINAL/TRANSVERSE CRACKING M 186.05 Ft

Sample Number: 05 Type: R Area: 5,200.00SqFt PCI = 78  
48 LONGITUDINAL/TRANSVERSE CRACKING L 193.05 Ft  
48 LONGITUDINAL/TRANSVERSE CRACKING M 115.03 Ft

Section: A01MA-01  
Longitudinal/ Transverse Cracking
